# **CFB ROCKLIFFE VEGETATION SURVEY**

## **ARBORIST'S REPORT**

Prepared by Dan Baker,  
Registered Professional Forester and Urban Forestry Consultant

January 2013

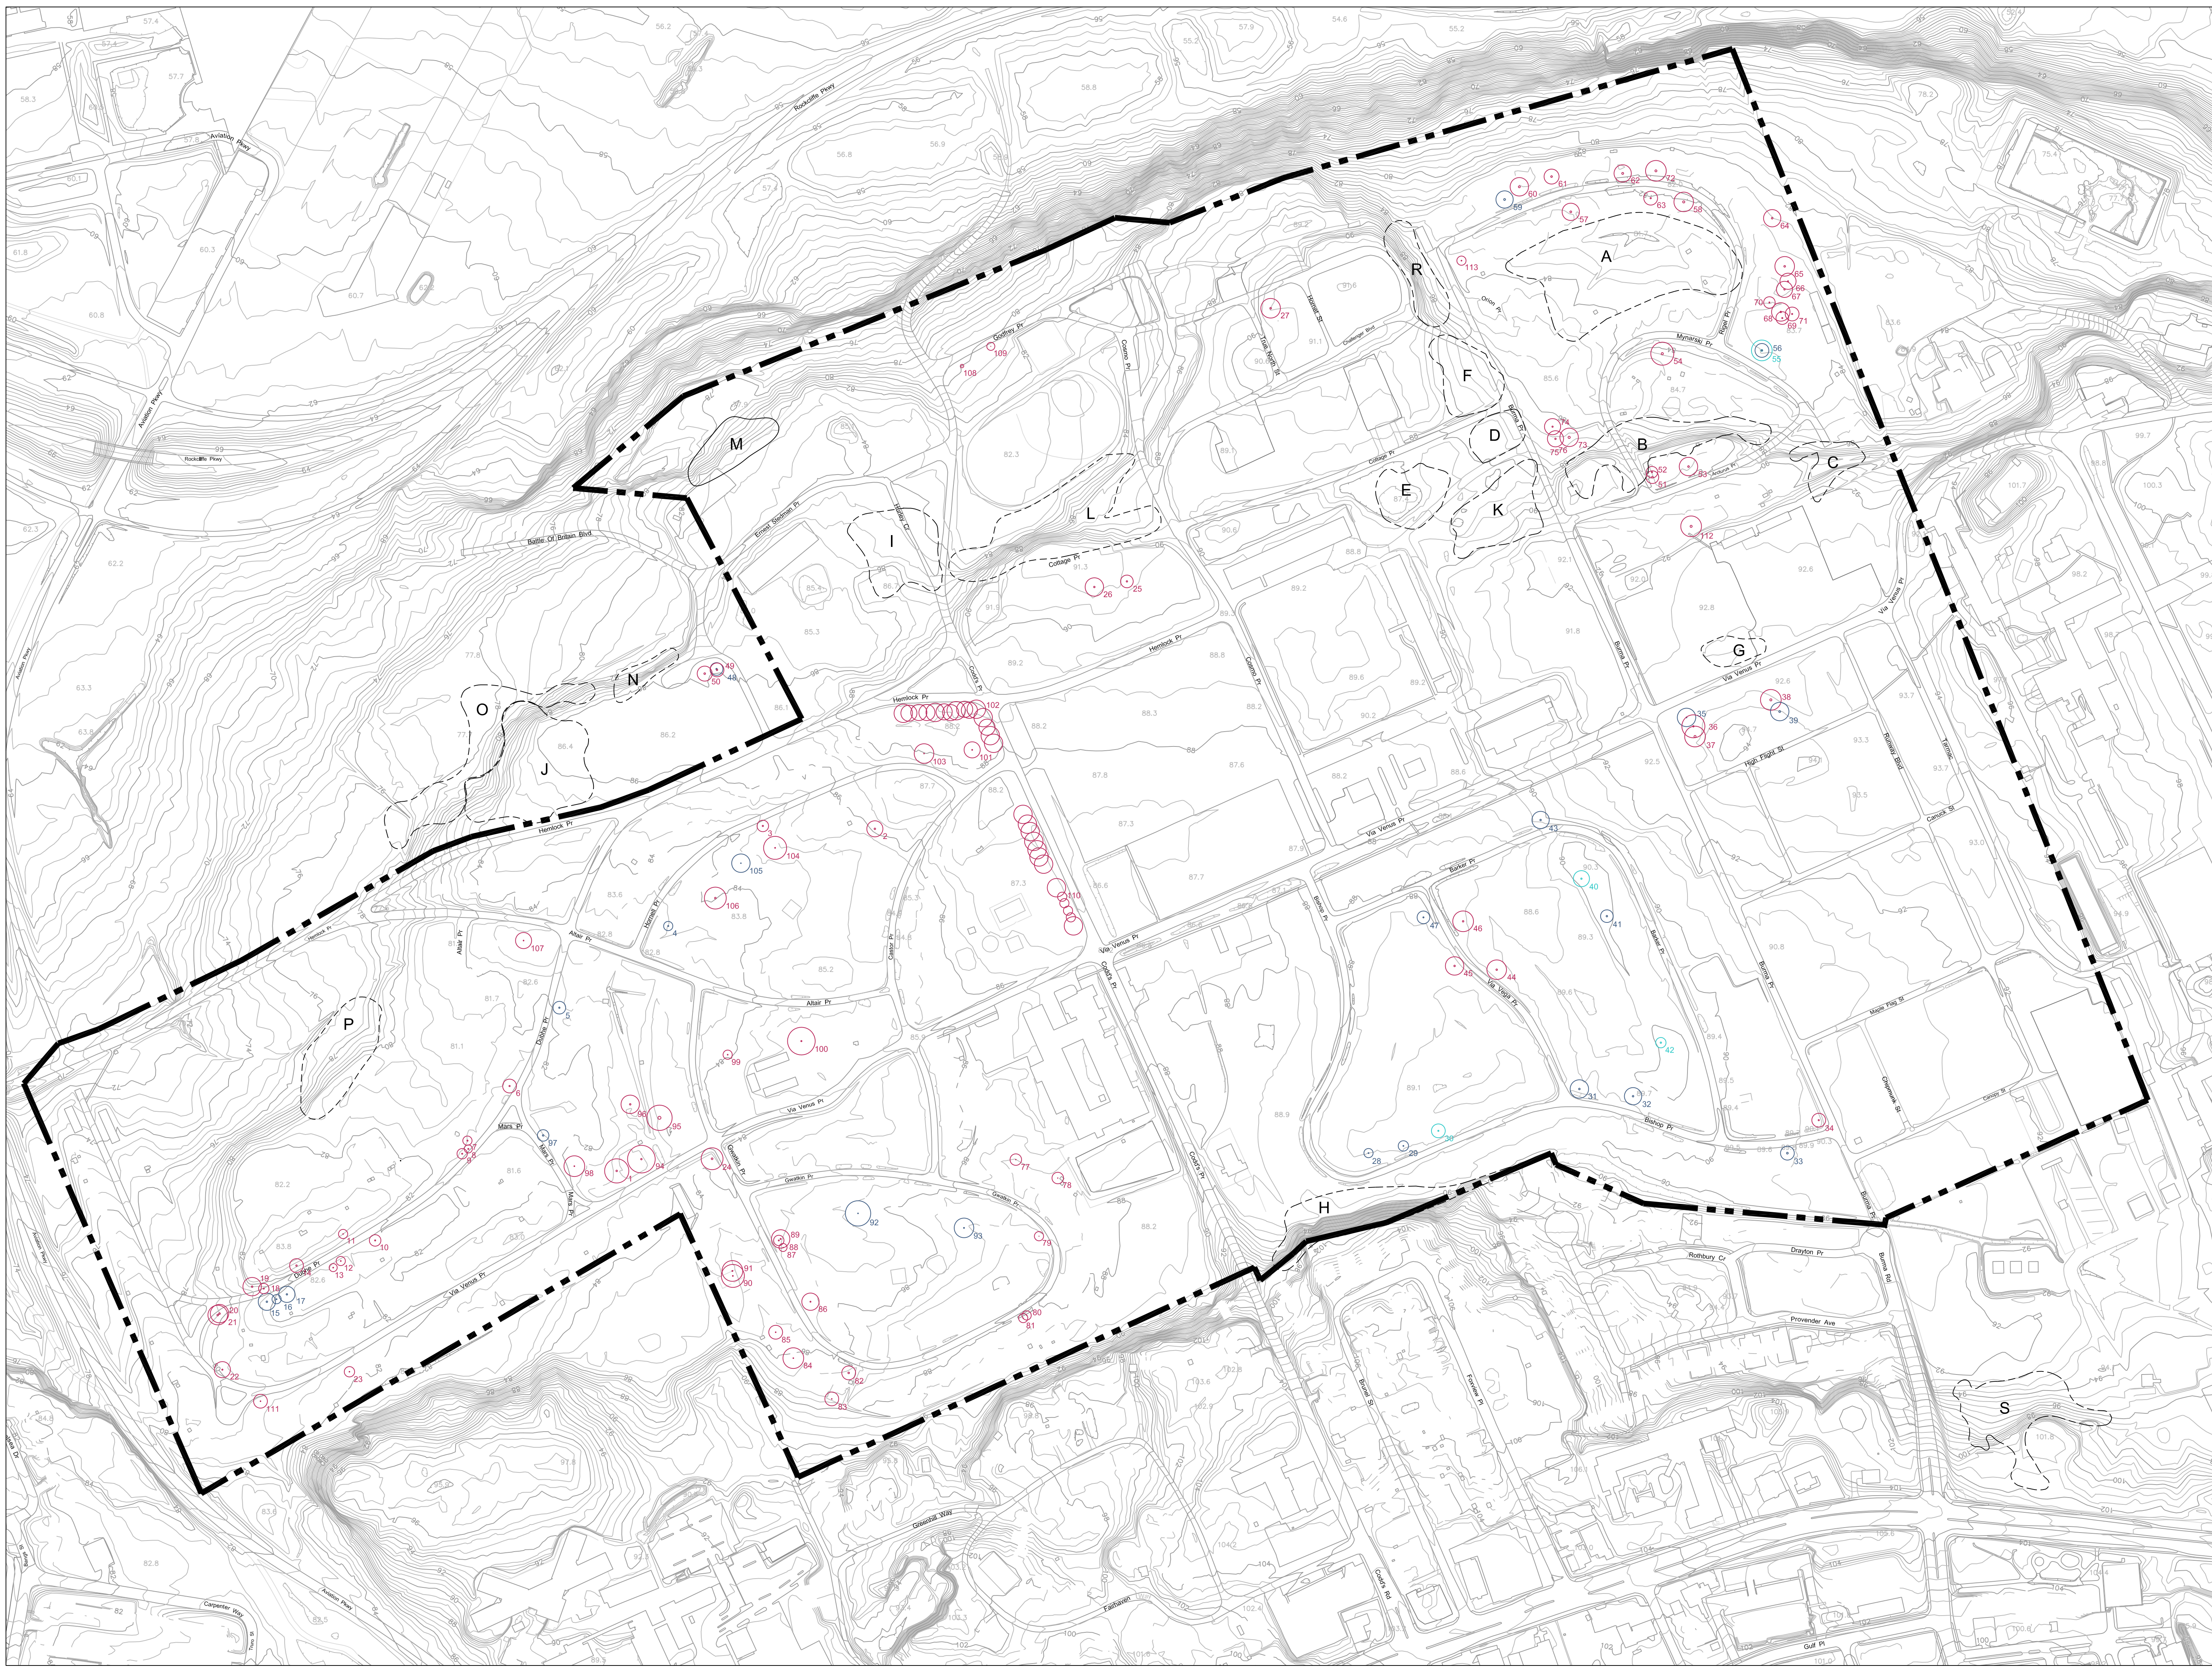
**L100**

SIGNIFICANT TREE - GOOD CONDITION
-   SIGNIFICANT TREE - FAIR CONDITION
-   SIGNIFICANT TREE - POOR CONDITION
-
